STRESS CORROSION CRACKING PROPERTIES OF STEAM GENERATOR TUBING ALLOYS IN CREVICE ENVIRONMENT

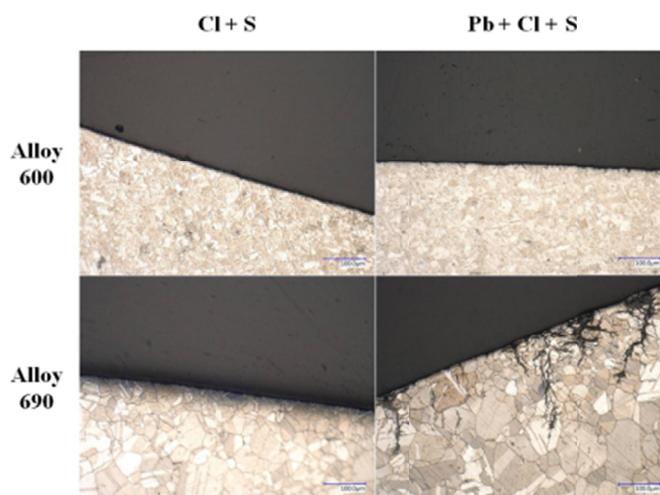
Fig. 1. Optical microscope images of Alloy 600 and 690 in Cl + S and Pb + Cl + S solutions

Optical microscope observation results are shown in Fig. 1 for the Pb + Cl + S group and Cl + S group. As shown in Fig. 1, the largest cracks were found for Alloy 690 in a solution containing Pb while no cracks were found for Alloy 690 in a solution without Pb. The shape of the cracks was complex, and most of the cracks were observed to be transgranular, similarly to other reports [8]. Unlike Alloy 690, cracks were found for Alloy 600 in all conditions. However, the cracks for Alloy 600 were significantly shorter than those for Alloy 690 in the solution containing Pb. It is presumed that the shape and existence of the surface oxide film can affect the SCC.

While Alloy 690 was very resistant to SCC in test solutions without Pb, it became highly susceptible to SCC in the leaded solution of pH(T) 9.5 at 310°C and was more sensitive to SCC by addition of other impurities (Cl and (or) S) in the leaded solution. Although it was possible to detect cracks for the Alloy 600 irrespective of impurities, the SCC rate for Alloy 690 was higher than that for the Alloy 600 in leaded solutions. From the observation of the surface oxide formed in the solutions containing Pb, it was found that non-uniform surface oxide film was observed for Alloy 690 in the solution containing Pb, which is suspicious of aggravation of SCC behavior.

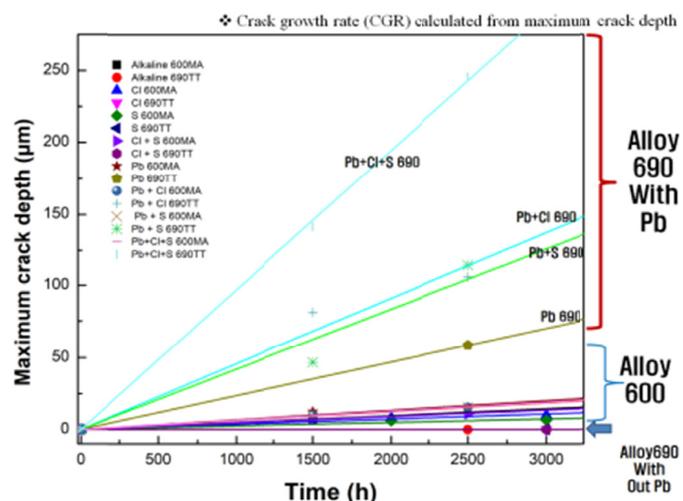
Fig. 2 displays the results of the experiments conducted in various environments. No cracks were observed for the Alloy 690 in the solution without Pb while cracks were found for Alloy 600 regardless of the presence of Pb. The crack growth rate for Alloy 690 in the solution containing Pb was higher than that for Alloy 600. Moreover SCC rate in leaded solution was increased with chlorine indicating that chlorine shows synergistic effect on SCC rate. Chlorine showed a greater effect on SCC than sulfur in the solution containing Pb. When sulfur, chlorine, and lead were added together, the SCC rate was the highest.

Fig. 2. Crack depth with immersion time for Alloy 600 and Alloy 690 in solutions containing different impurities

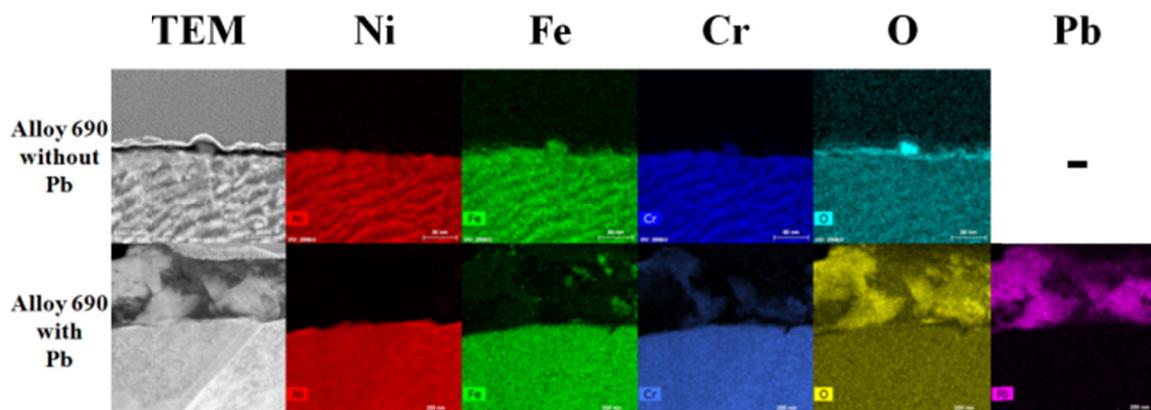
Fig. 3 shows the results of TEM for the surface oxide layer of Alloy 690. Alloy 690 had a uniform oxide film on the surface in the solution without Pb. However, the Pb oxide was detected and a uniform oxide was degraded on the surface of Alloy 690

Fig. 3. STEM-HAADF images and EDX elemental maps obtained from the apex of Alloy 690 both with and without Pb

when Pb was added to solution. It is expected that the shape and existence of the uniform oxide film affected the SCC in Alloy 690 considering that surface oxide plays a significant role in SCC behavior [9].
